TL  
242  
.E6546  
1989

U.S. Department  
of Transportation  
**National Highway  
Traffic Safety  
Administration**

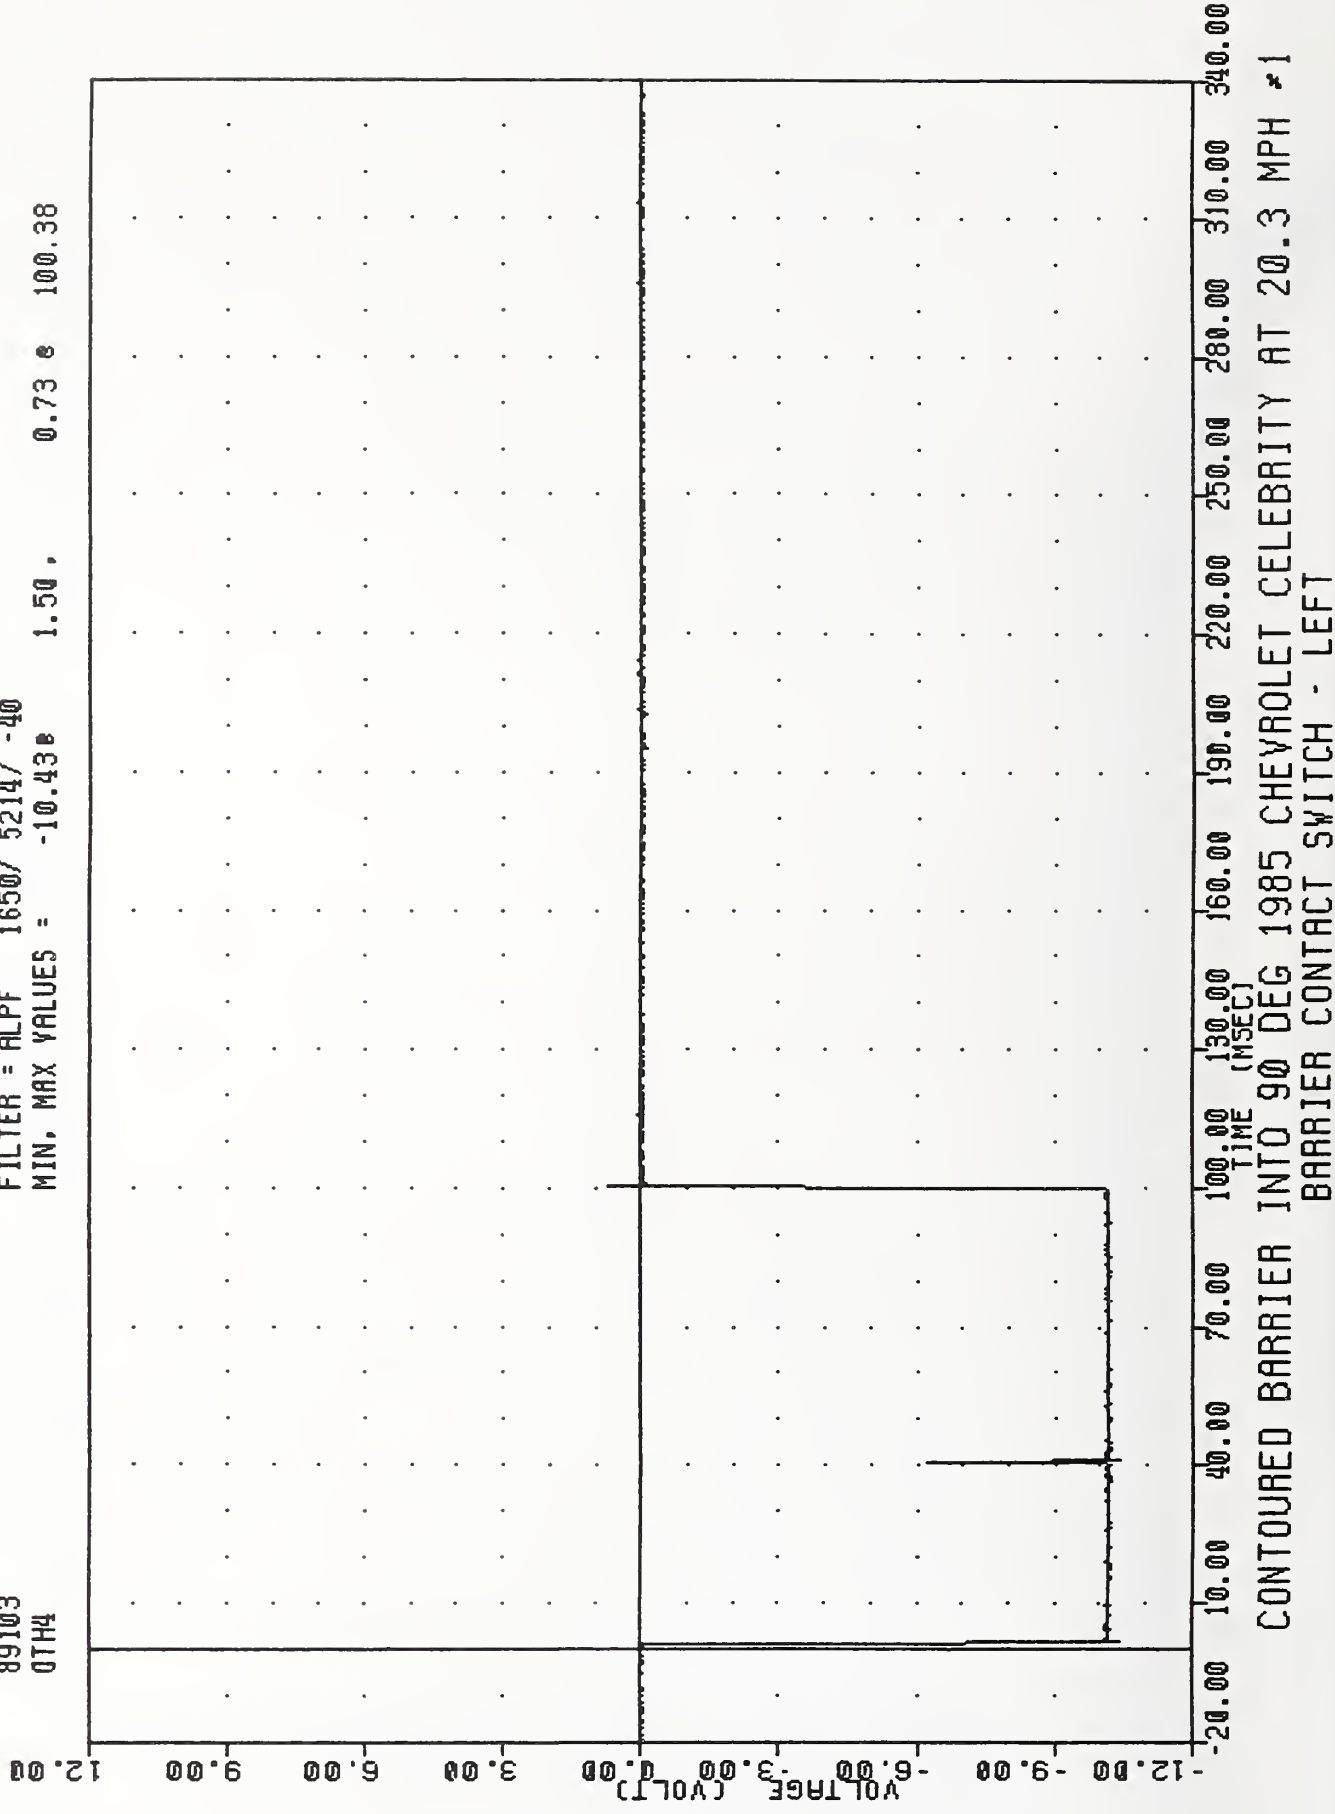
CONTOURED BARRIER INTO 90 DEG 1985 CHEVROLET CELEBRITY AT 20.3 MPH #1  
BARRIER CONTACT SWITCH - LEFT

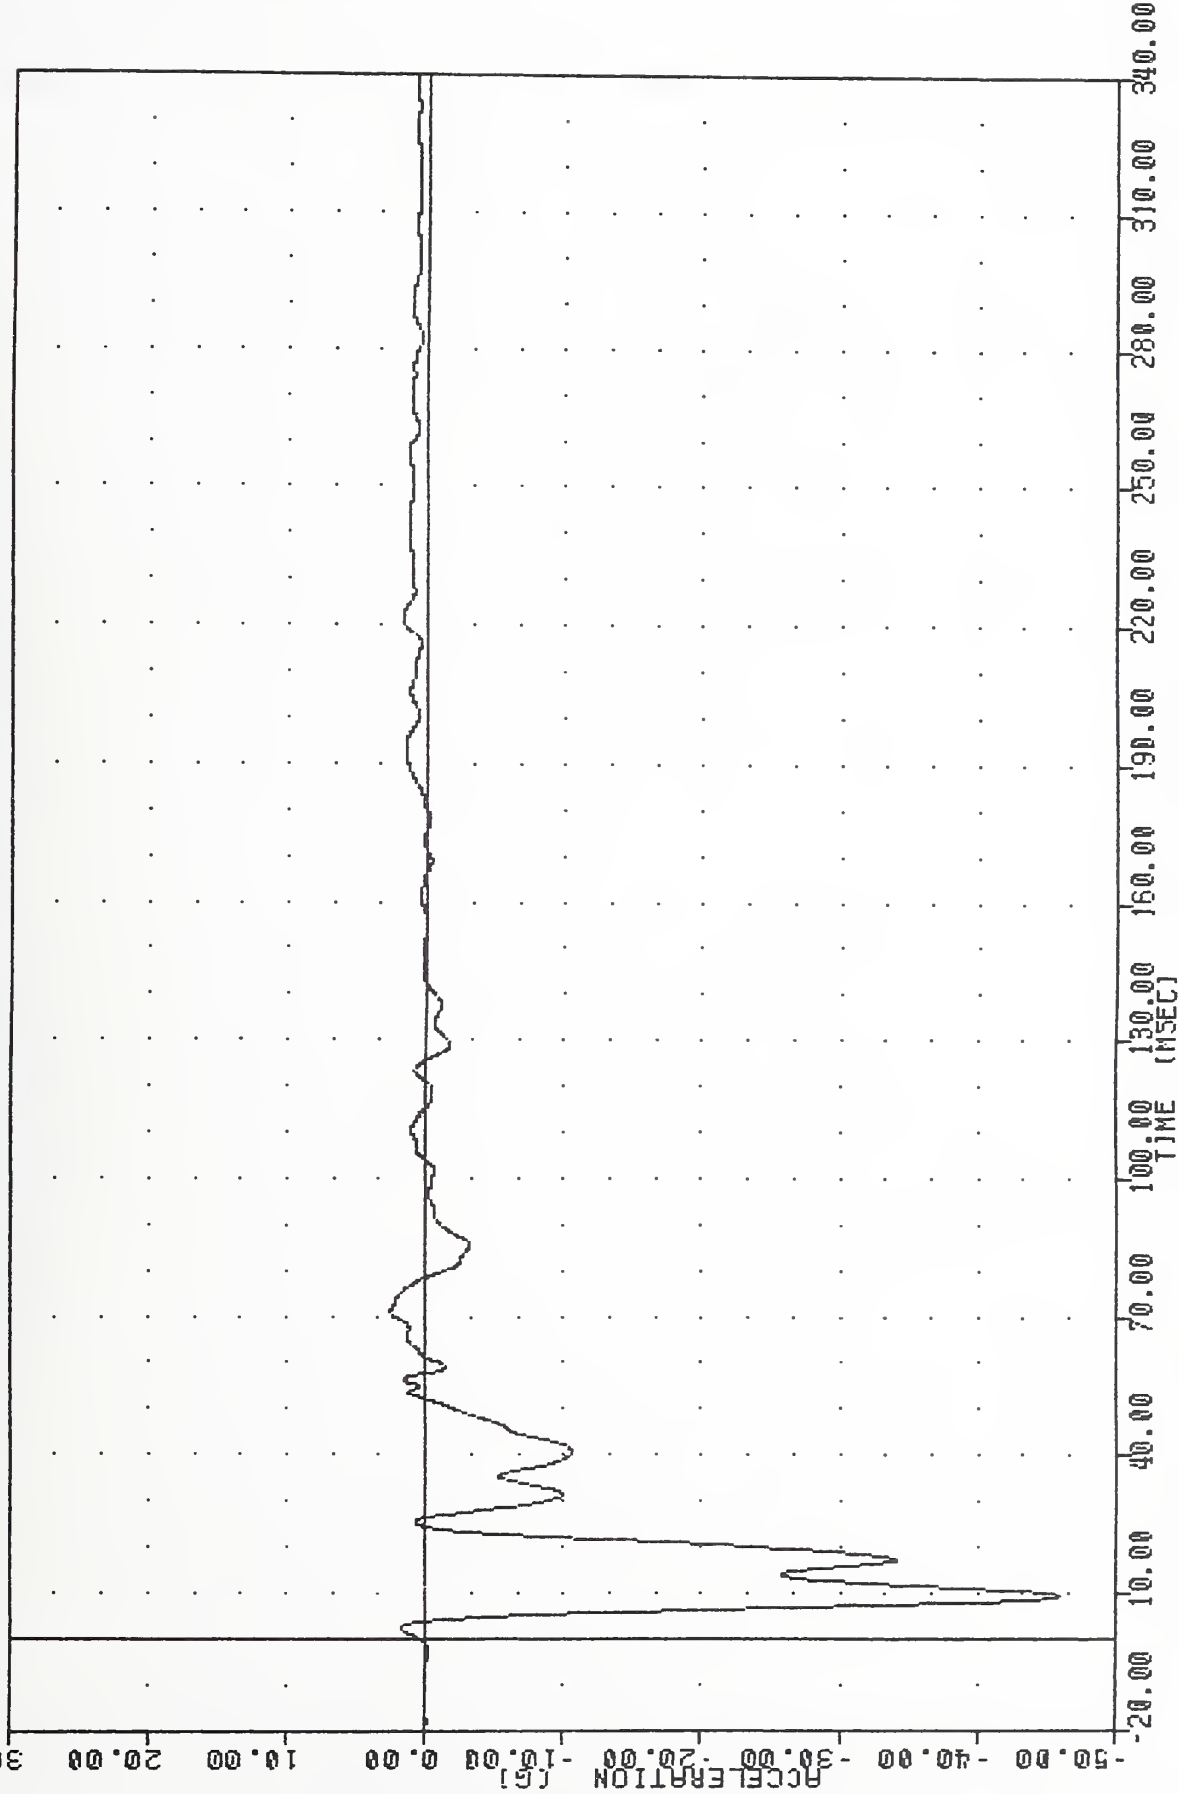
CONTOURED BARRIER INTO 90 DEG 1985 CHEVROLET CELEBRITY AT 30.1 MPH #2  
VEHICLE RIGHT FRONT SILL Y AXIS ACCELERATION

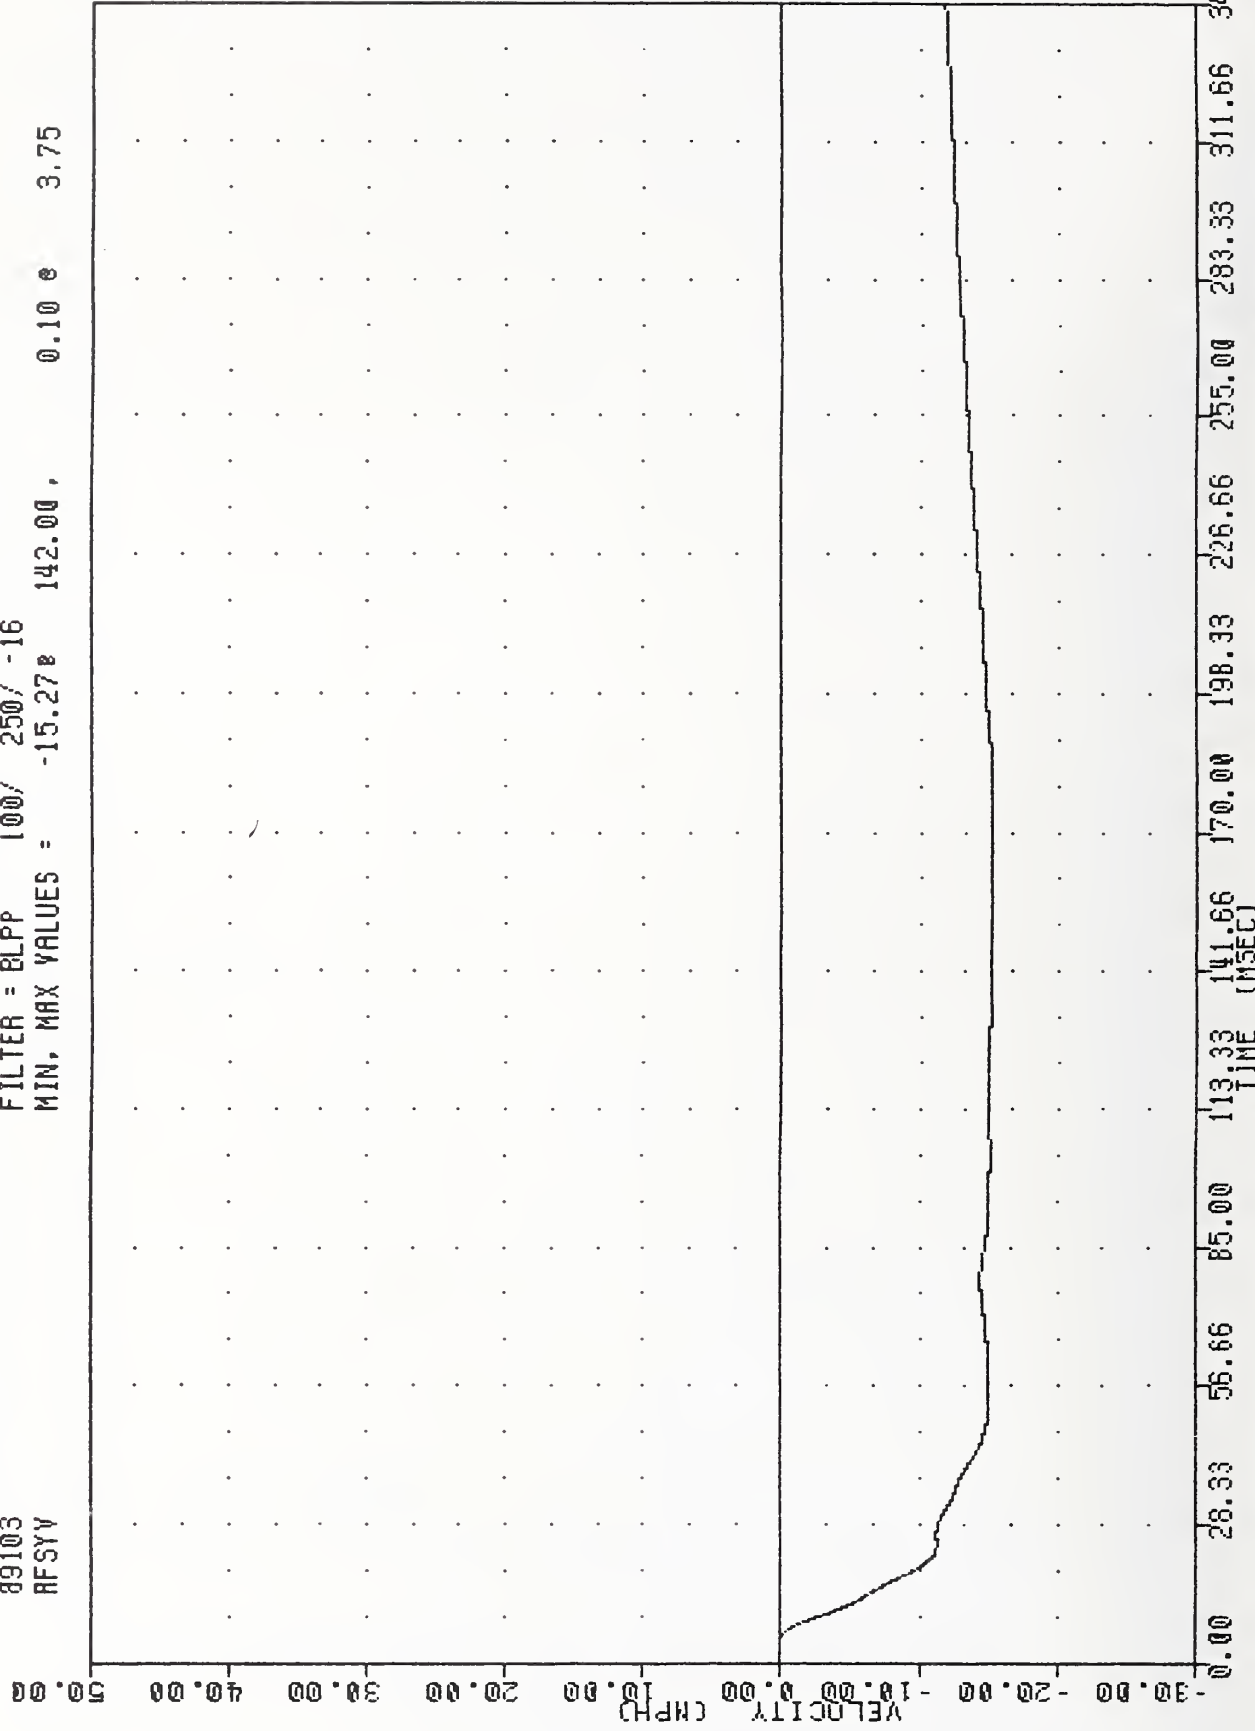
CONTOURED BARRIER INTO 90 DEG 1985 CHEVROLET CELEBRITY AT 30.1 MPH #2  
 VEHICLE RIGHT FRONT SILL Y AXIS VELOCITY

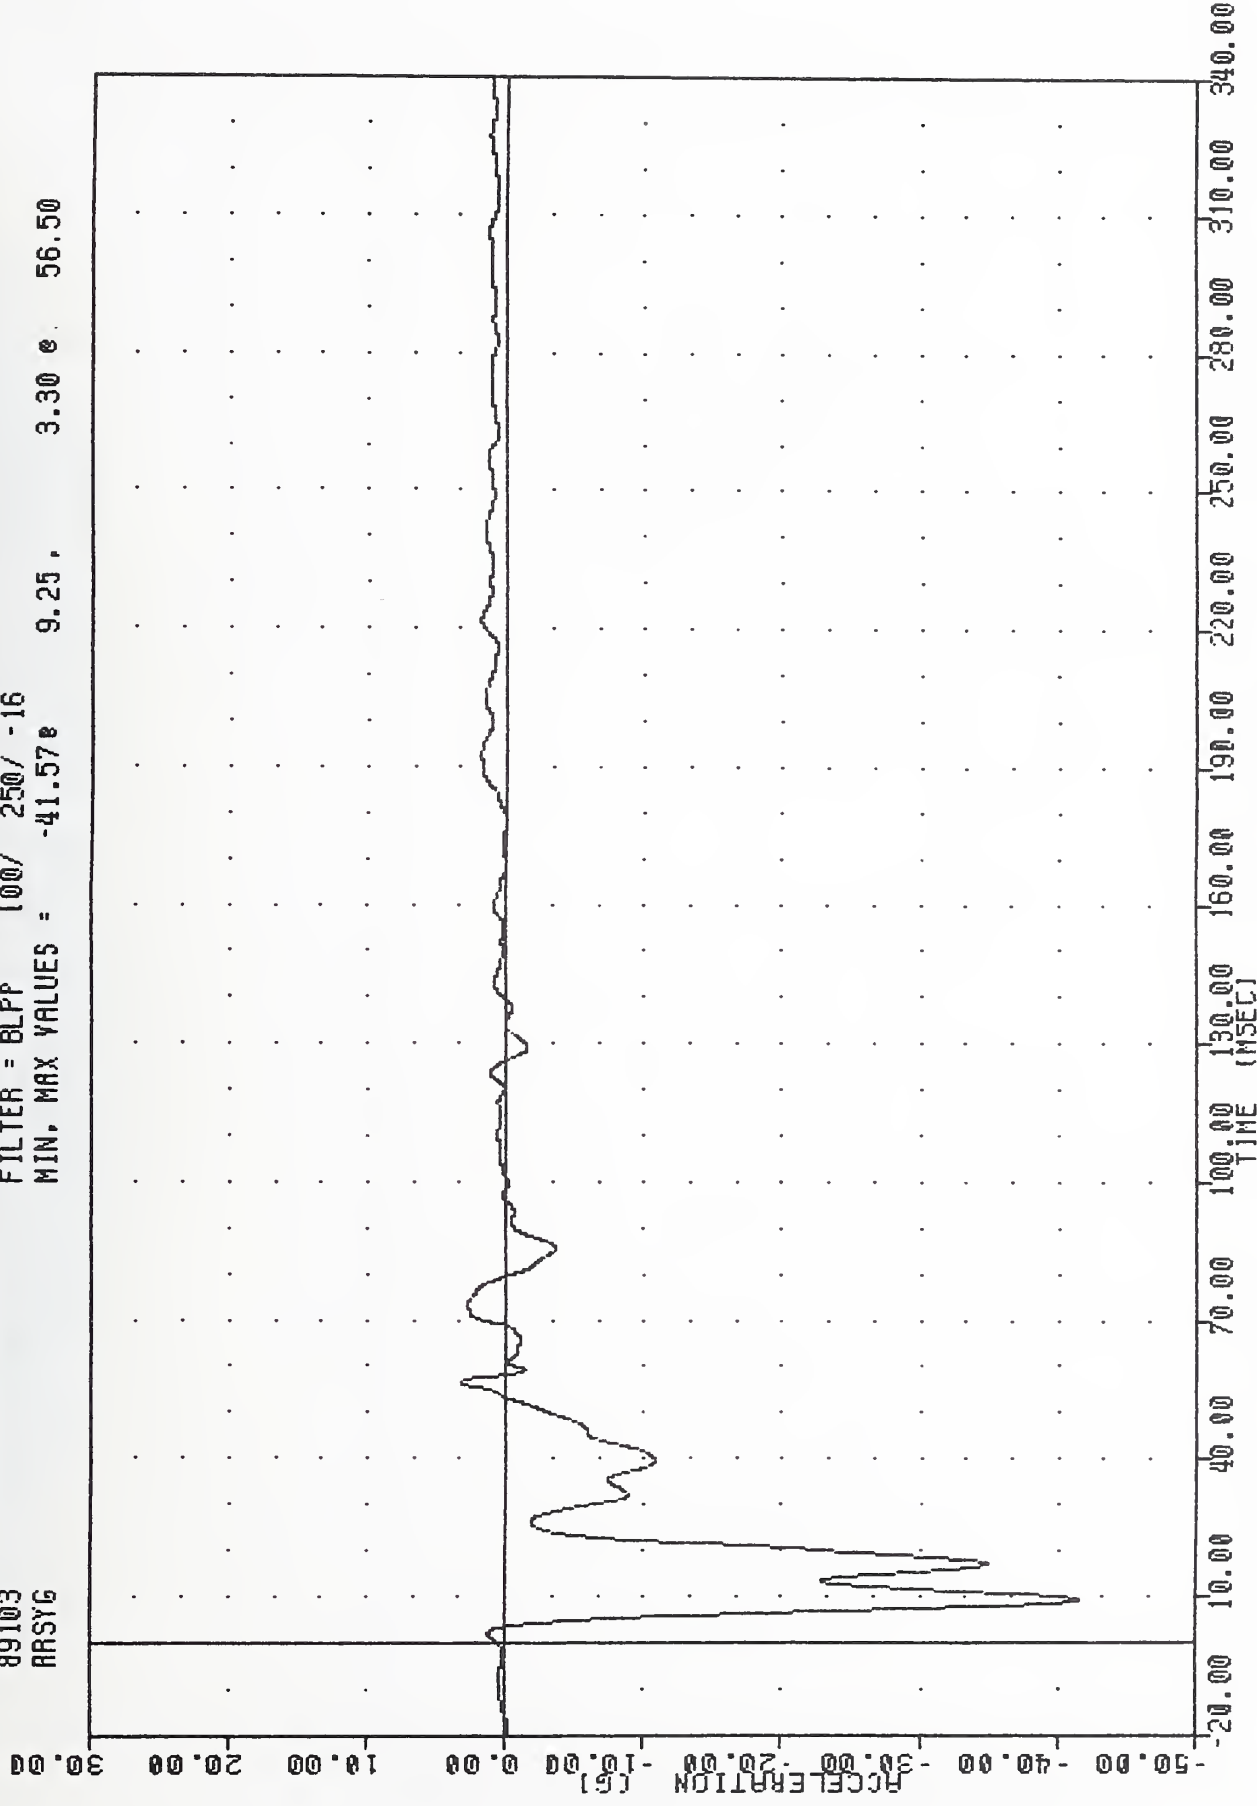
CONTOURED BARRIER INTO 90 DEG 1985 CHEVROLET CELEBRITY AT 30.1 MPH #2  
VEHICLE RIGHT REAR SILL Y AXIS ACCELERATION

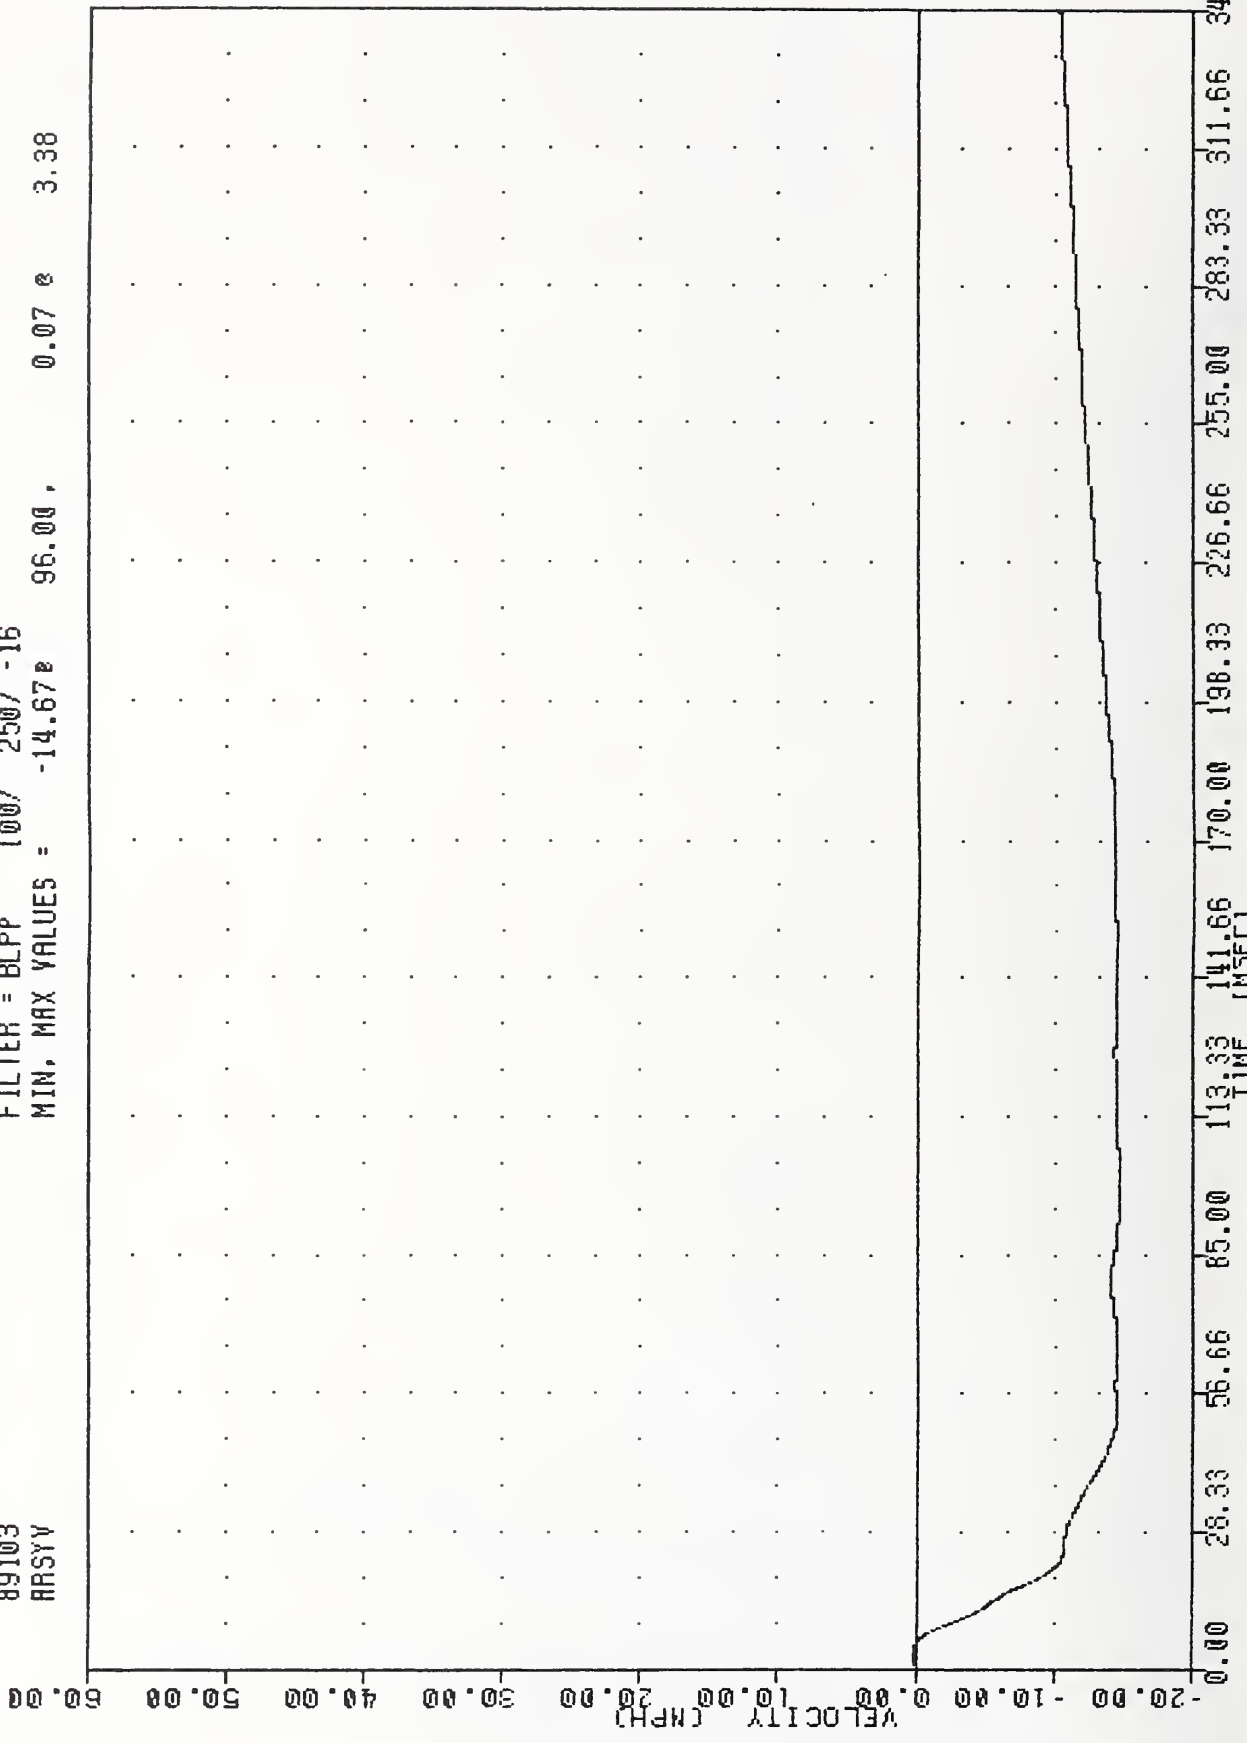
CONTOURED BARRIER INTO 90 DEG 1985 CHEVROLET CELEBRITY AT 30.1 MPH \*2  
 VEHICLE RIGHT REAR SILL Y AXIS VELOCITY

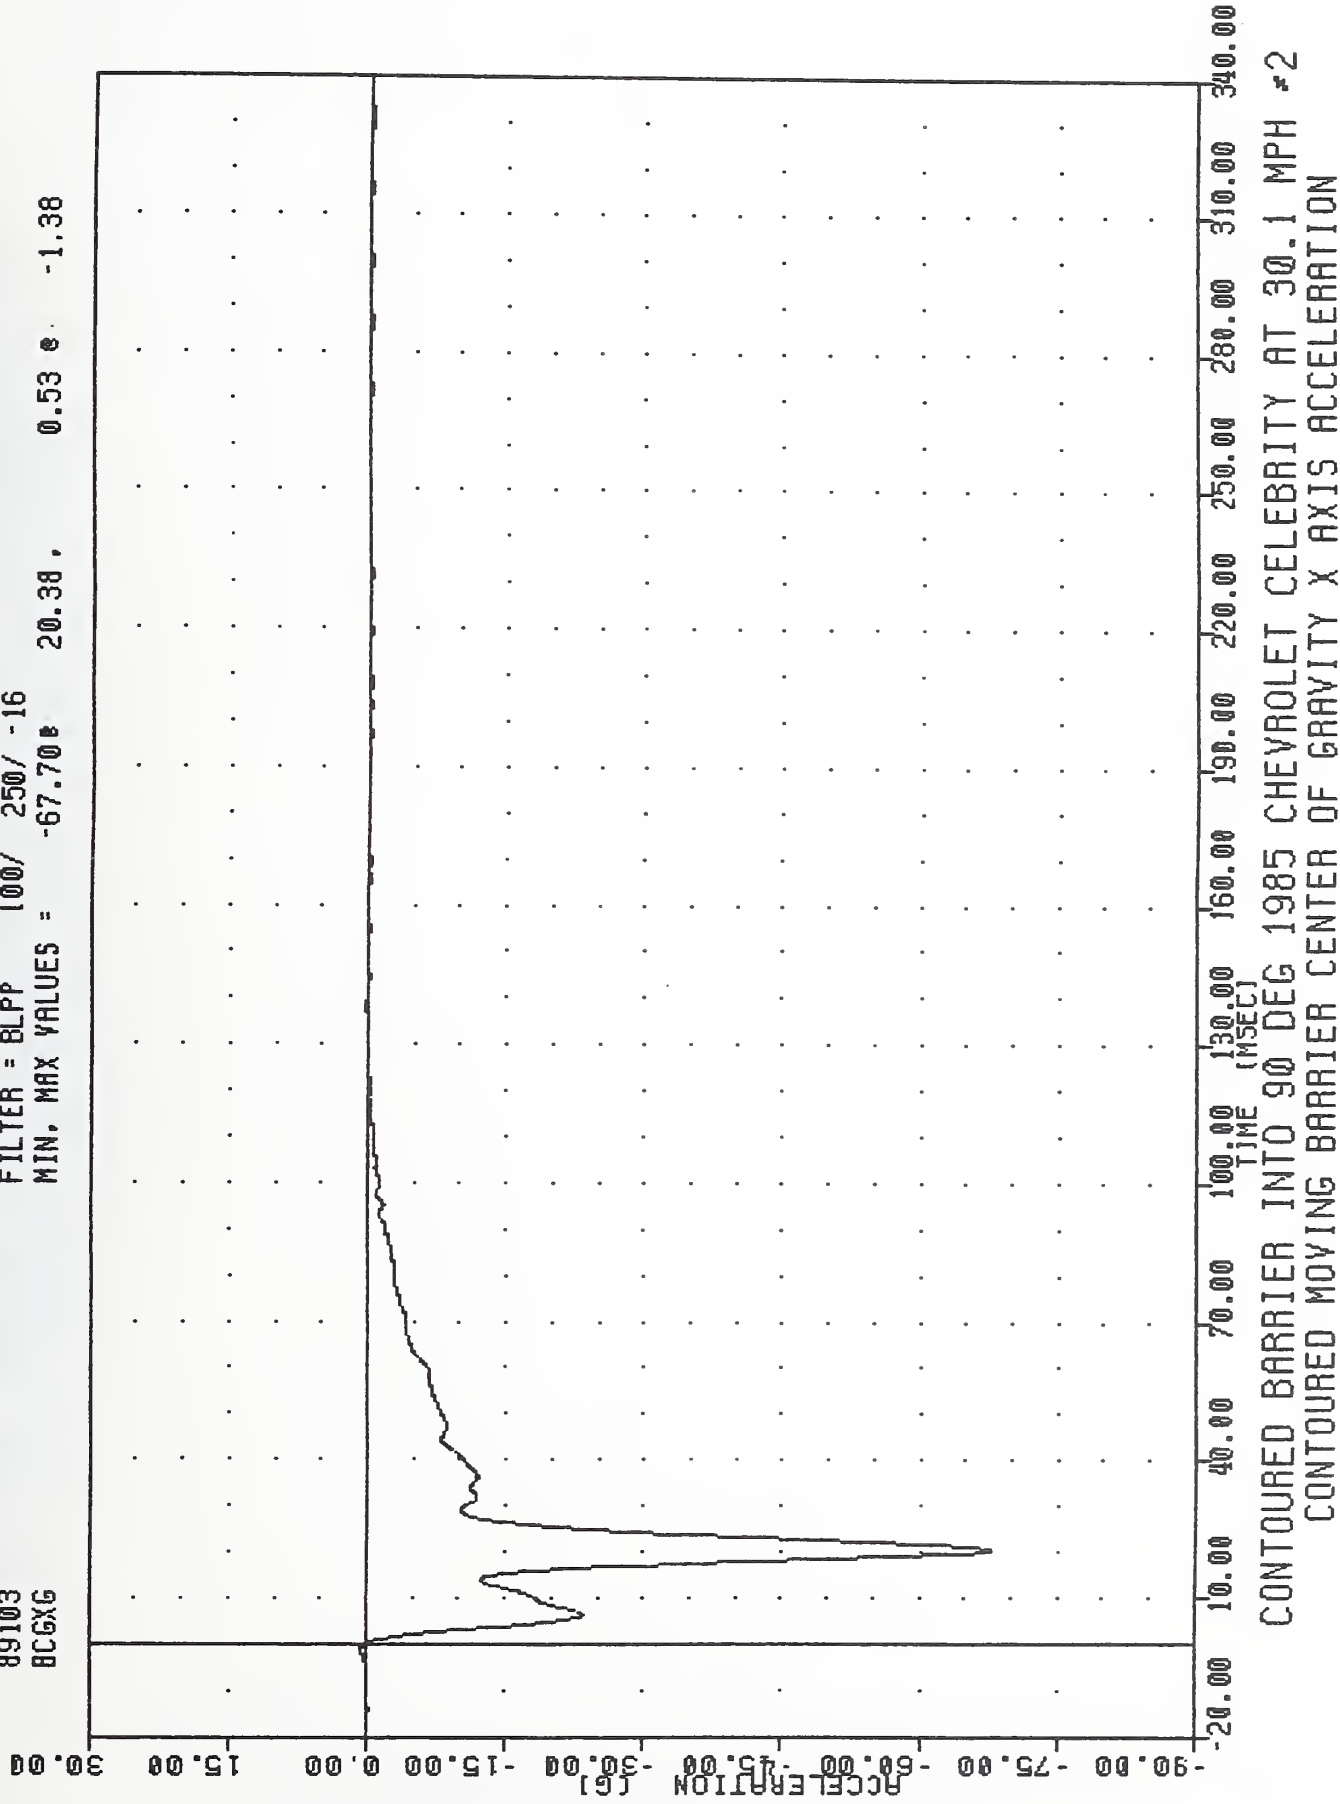
VRTC-2 , 890413-2  
 CRASH III DAMAGE ALGORITHM  
 89103  
 BCGXY

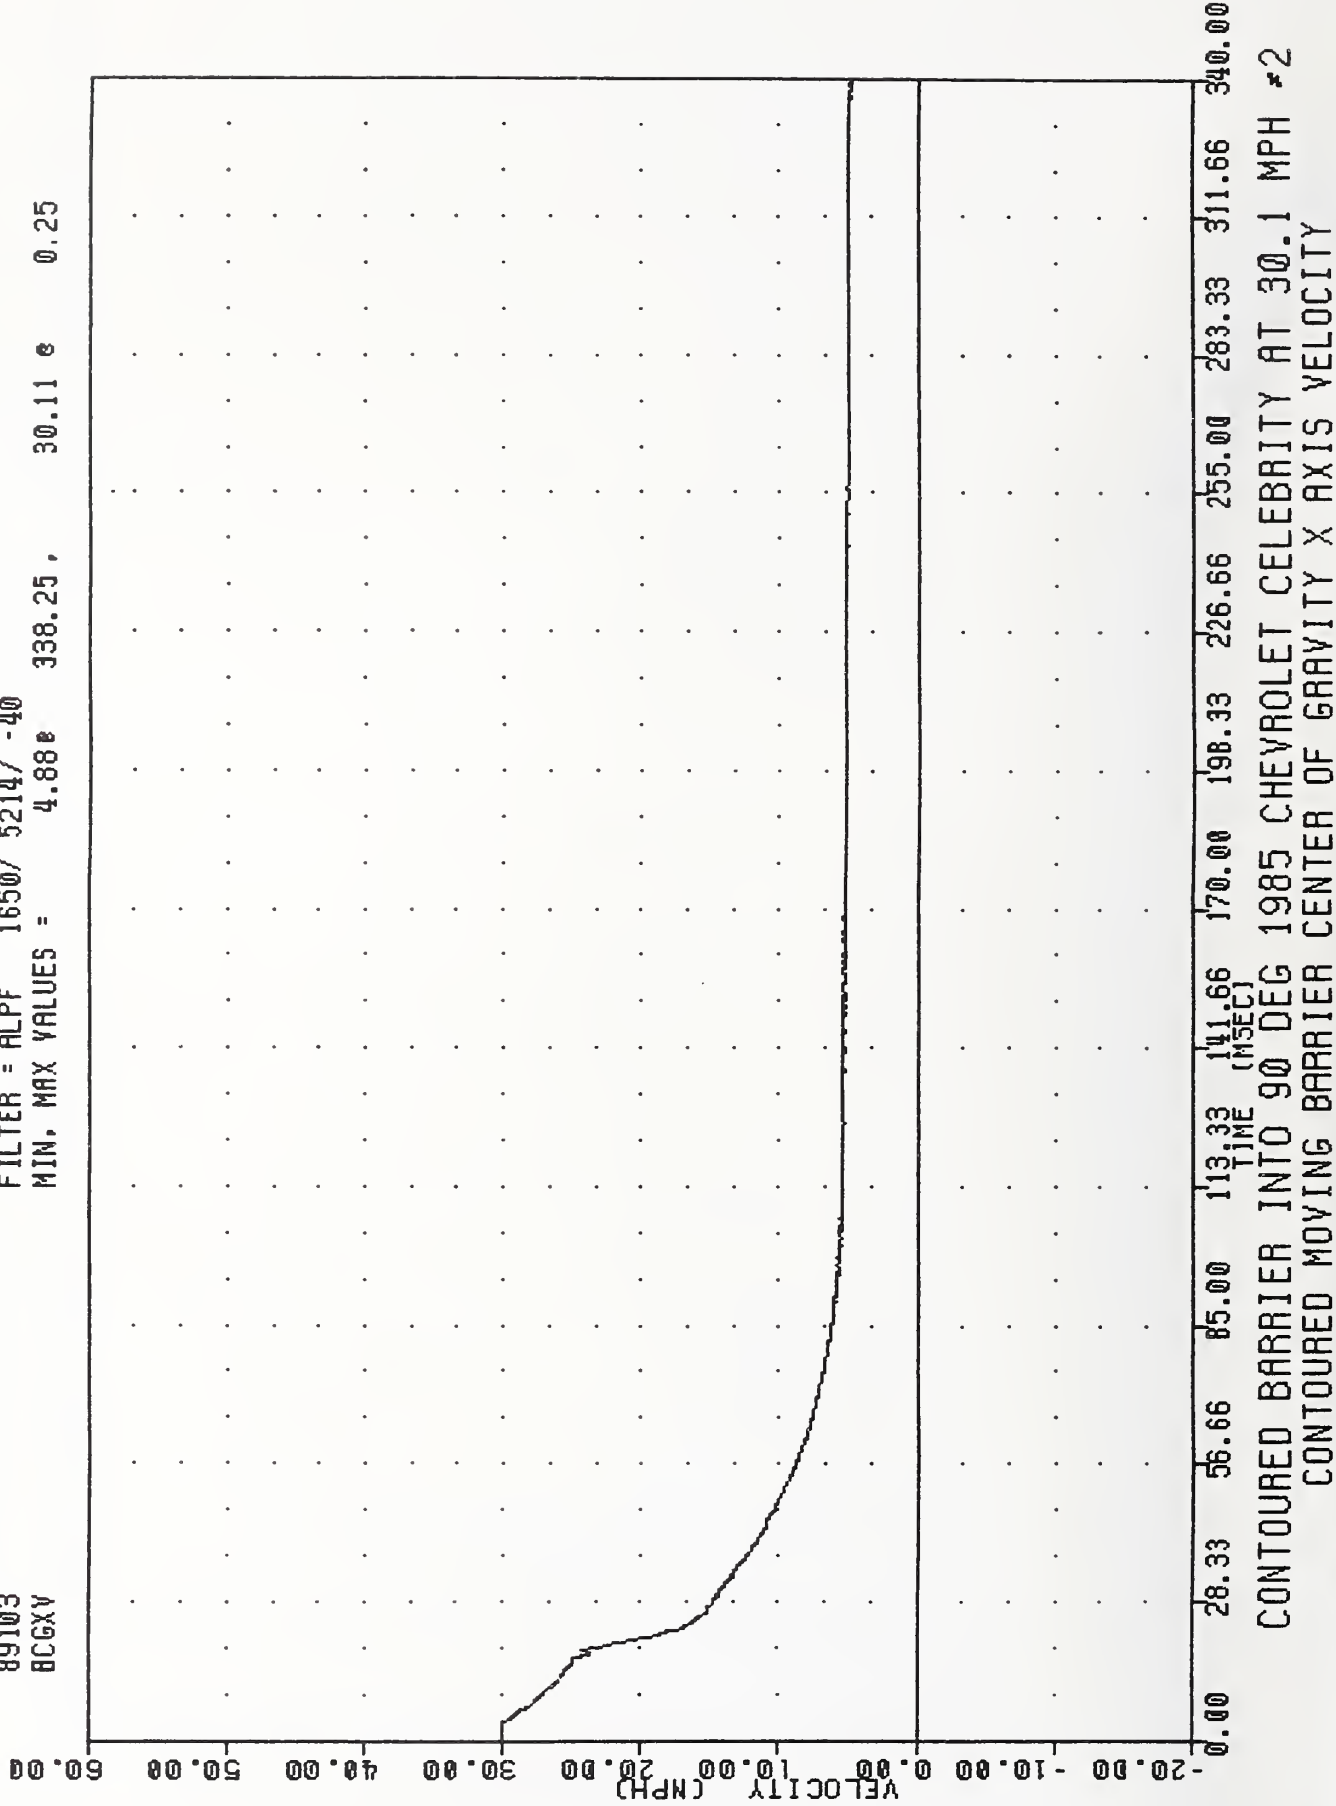
VRTC-2 , 890413-2  
CRASH III DAMAGE ALGORITHM

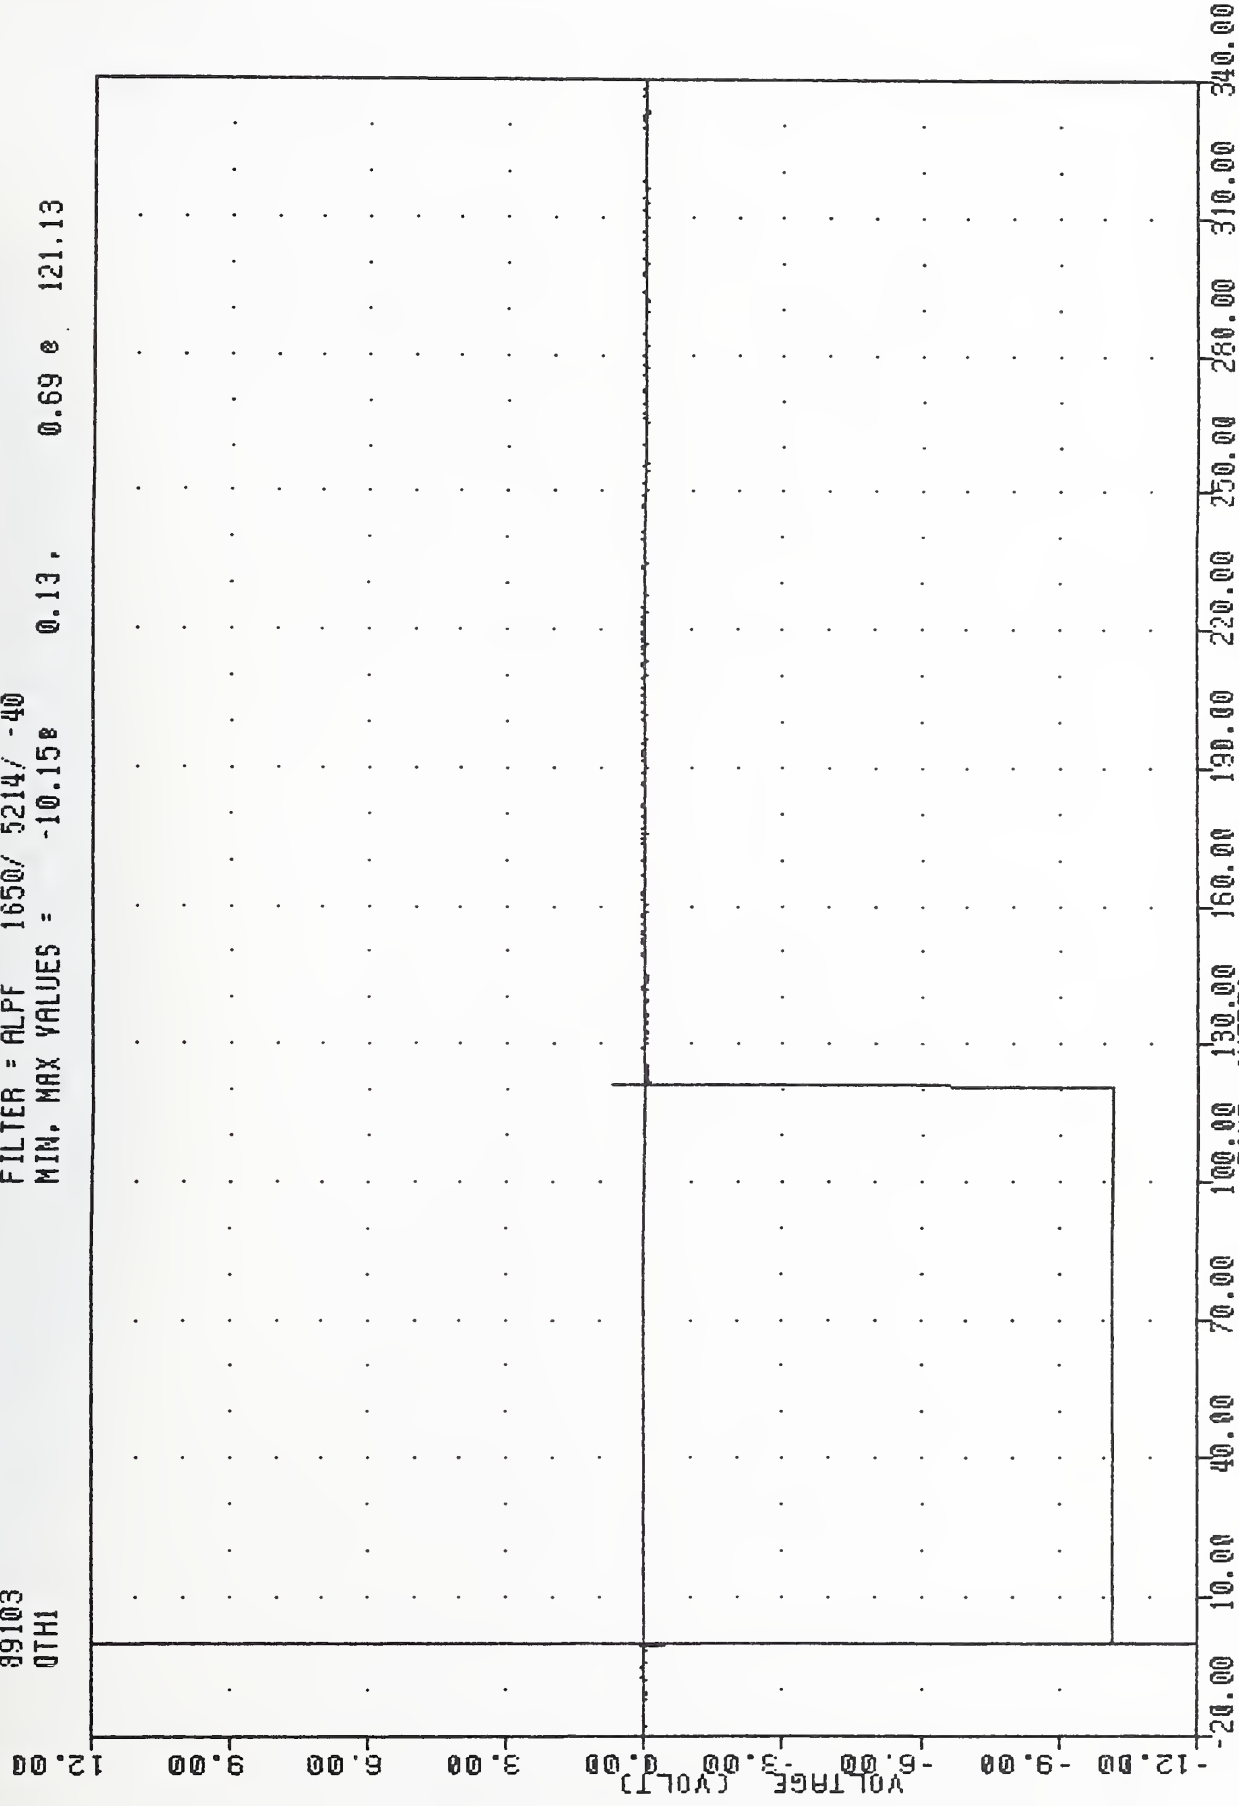
CONTOURED BARRIER INTO 90 DEG 1985 CHEVROLET CELEBRITY AT 30.1 MPH #2  
VEHICLE CONTACT SWITCH - FRONT

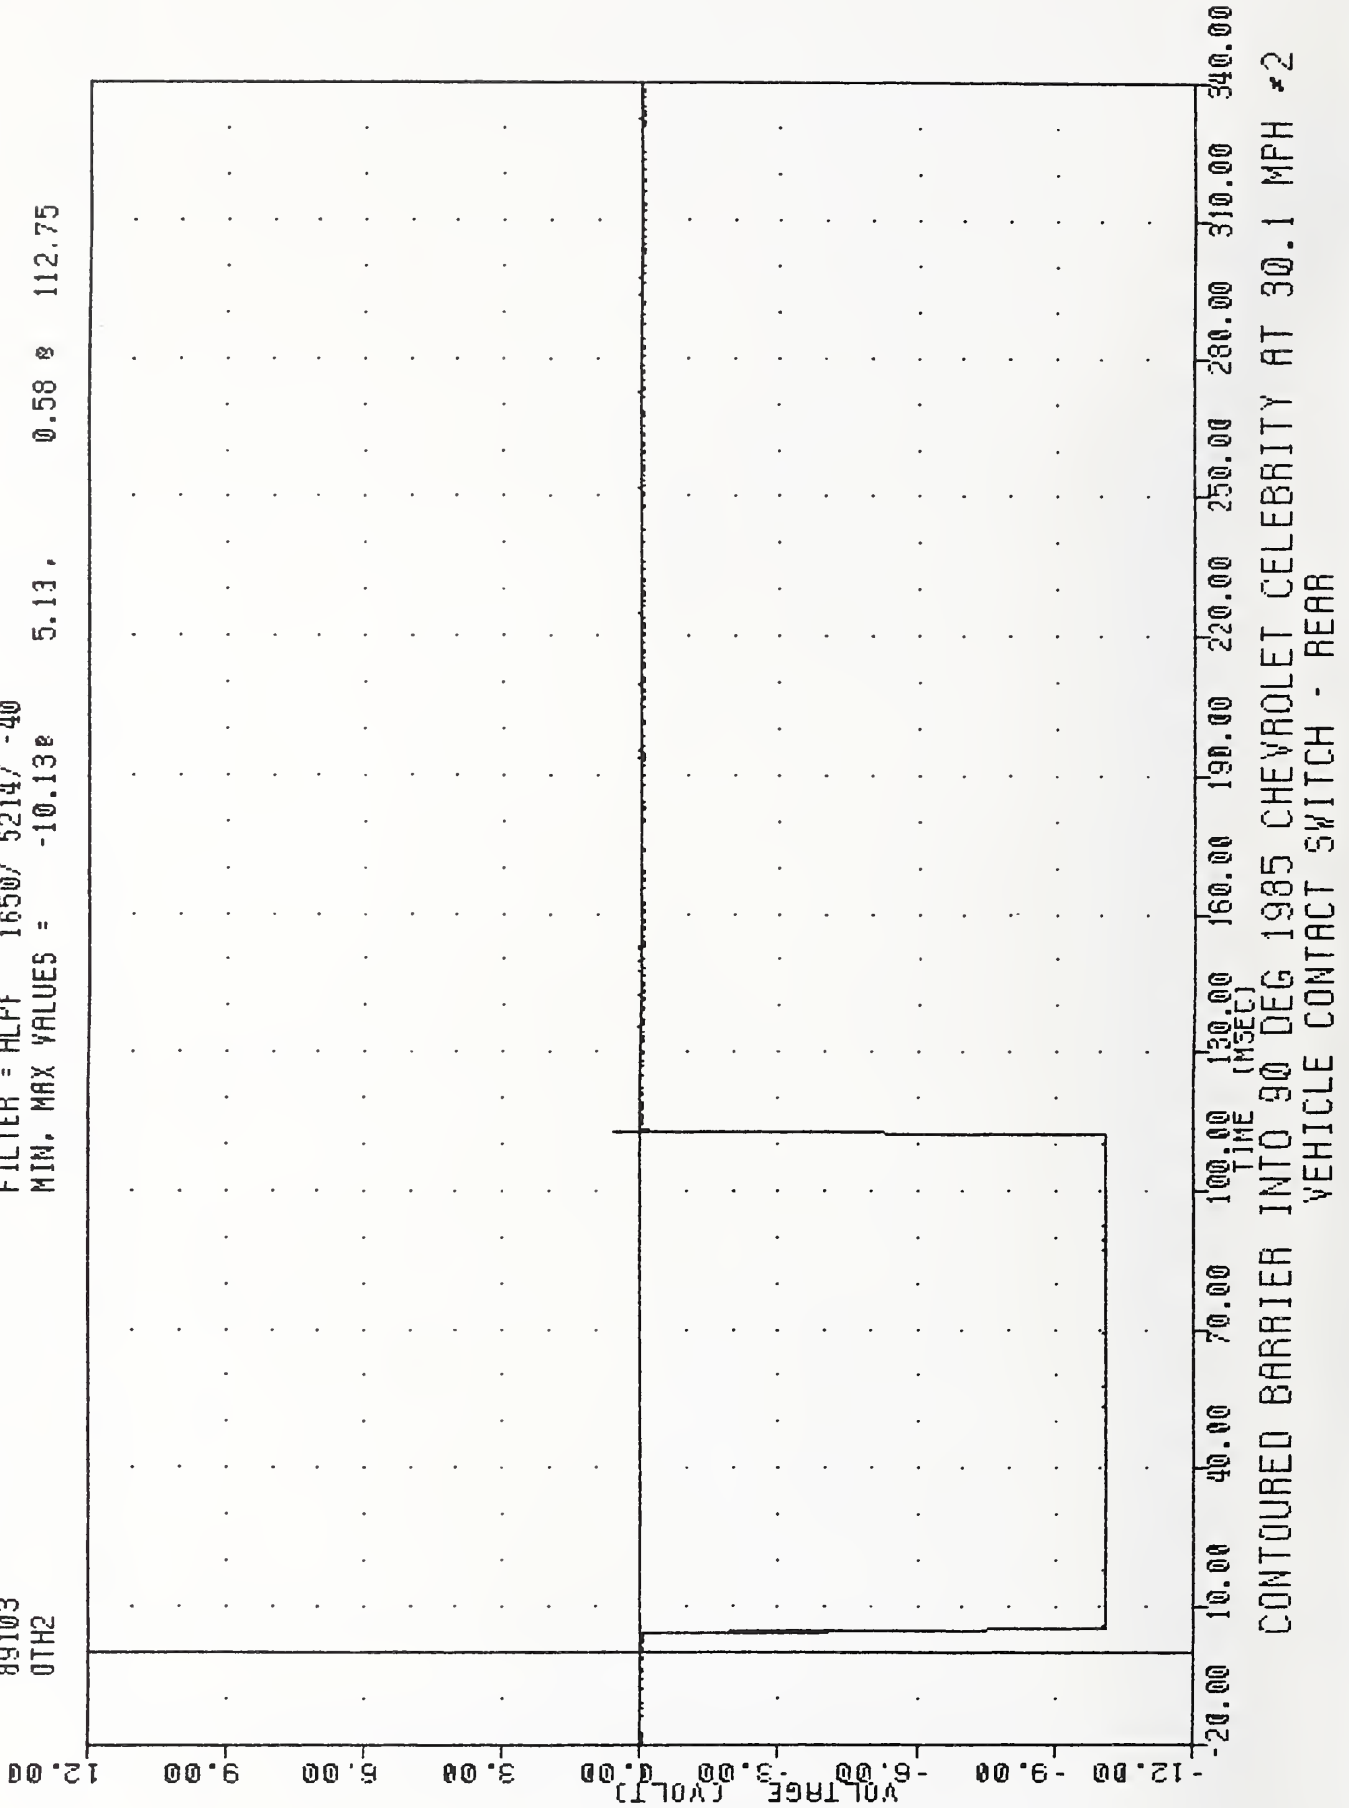
VRTC-2 , 890413-2  
CRASH III DAMAGE ALGORITHM

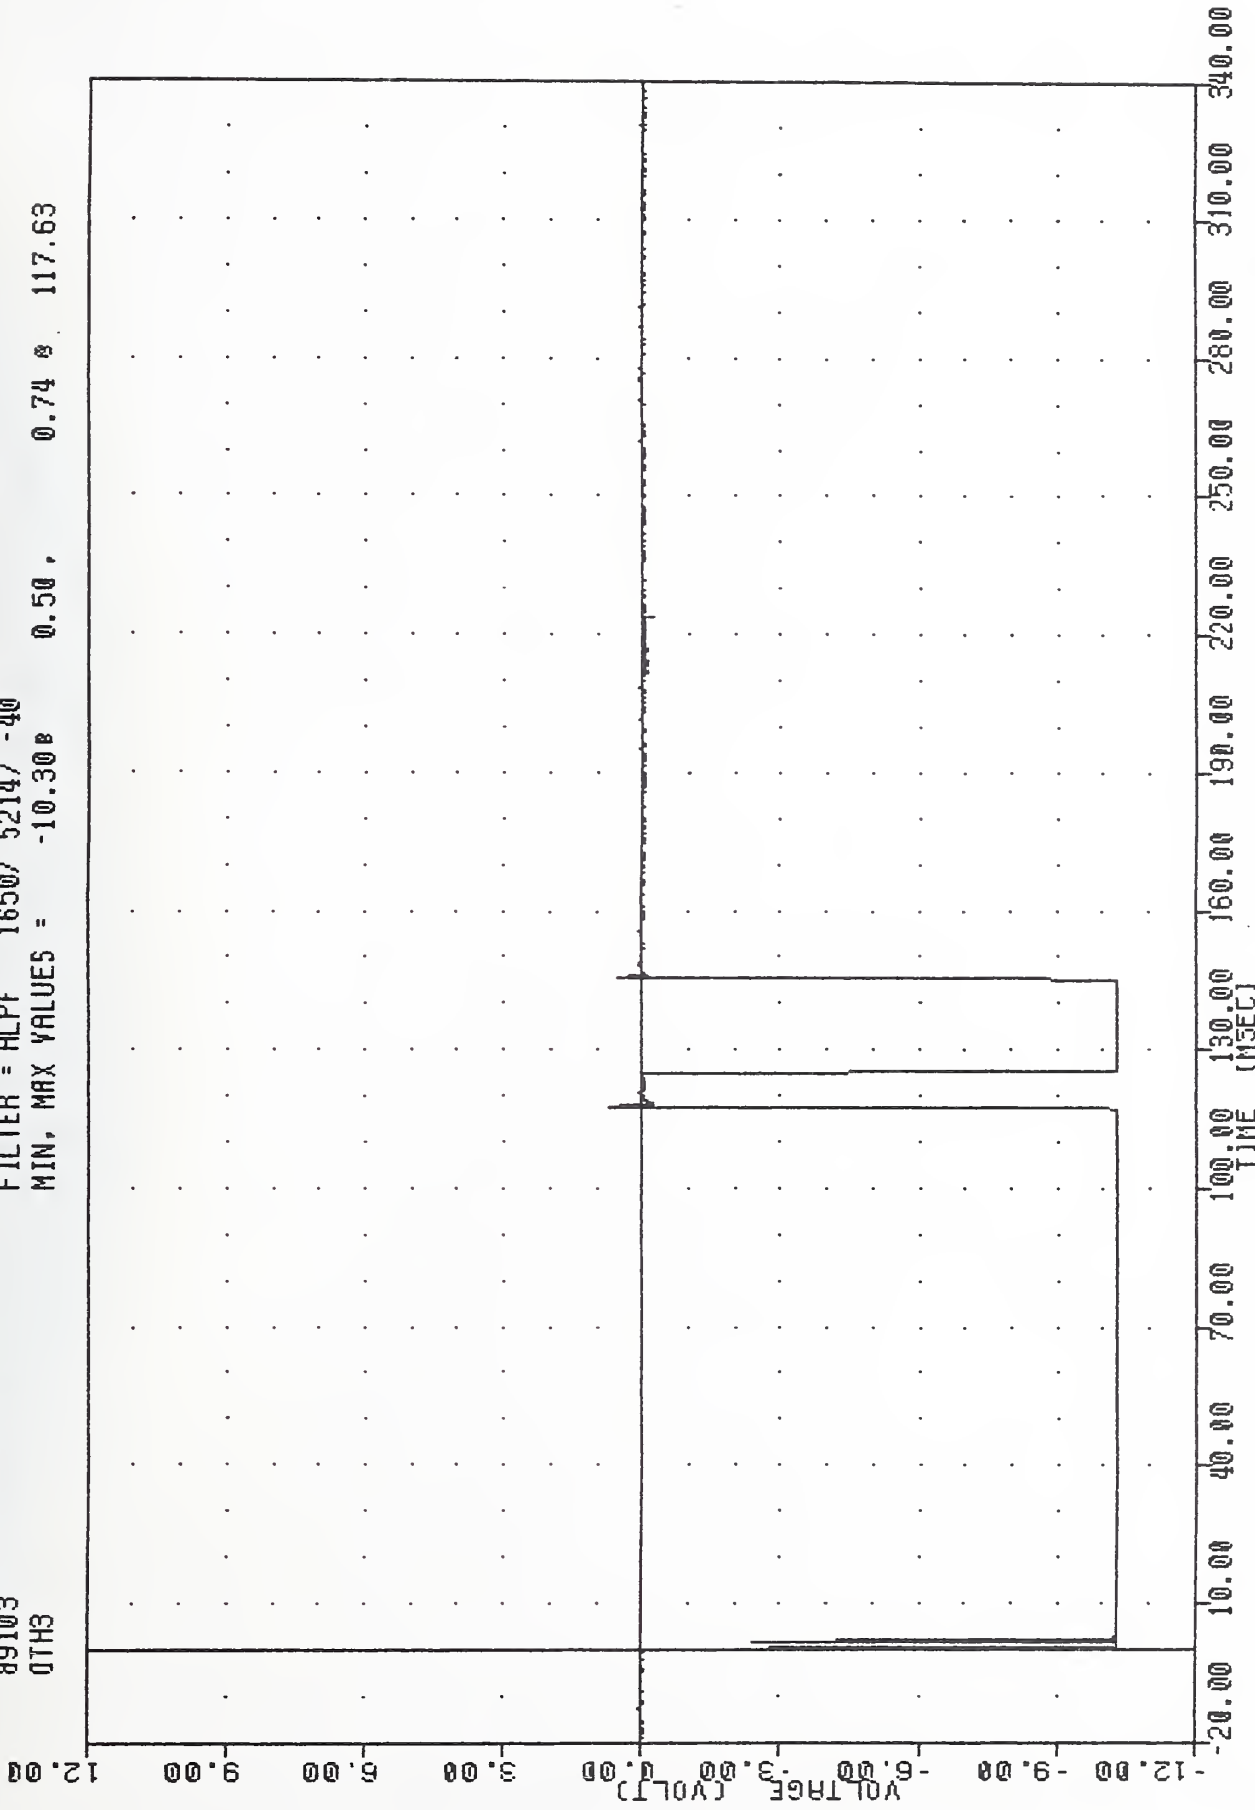
CONToured BARRIER INTO 90 DEG 1985 CHEVROLET CELEBRITY AT 30.1 MPH #2  
BARRIER CONTACT SWITCH - RIGHT
